Constraints of
Habitat and Channel Stability on the Development of
Drainage Improvement Alternatives for the S-1 to S-3 and N-1 to N-5 Urban Planning Zones

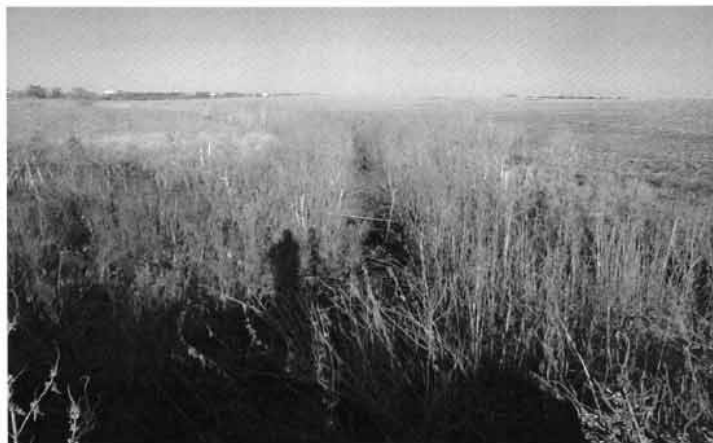
Photograph 2. Stream channel immediately upstream of 40th Street in the S-2 catchment. Riparian vegetation has been removed for agricultural development.

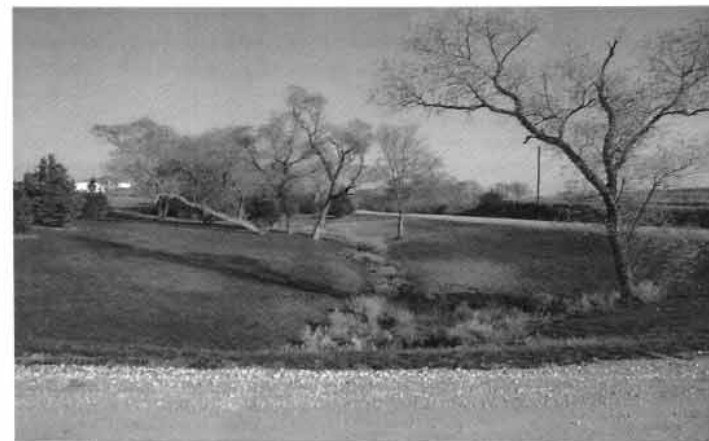
Photograph 3. Drainageway in Catchment S-3 adjacent to Rokeby Road.

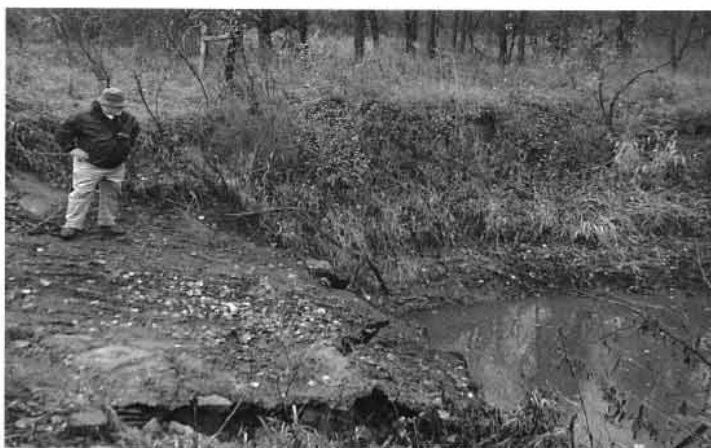
Photograph 4. Channel with head cutting or scour hole downstream of channel.

The N-2, N-3 and N-5 catchments have agricultural development. The channels in these catchments show head cutting and vertical incision. (See photographs 4 and 5.) Catchment N-4 does not show channel incision but has deposition in some areas.

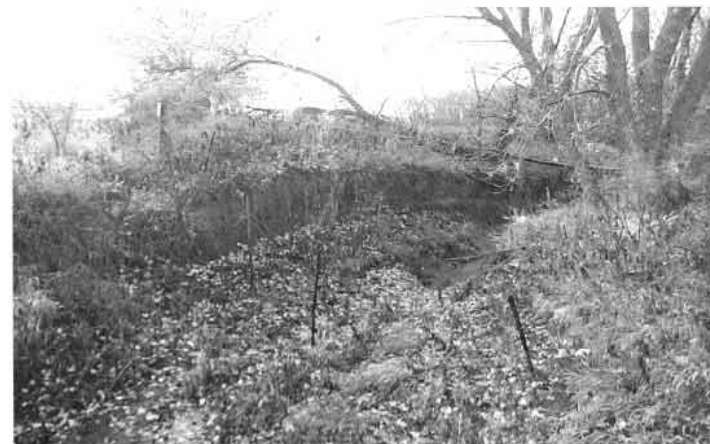
Photograph 5. Channel with vertical incision.
